**Draft Site and Reach Assessment
Coe Clemmons Creeks
at SR203**

**Garrett Jackson, Hydrologist
WSDOT Environmental Services
Hydrology Program
June, 2010**

Site and Reach Assessment, Coe Clemmons Creek at SR203

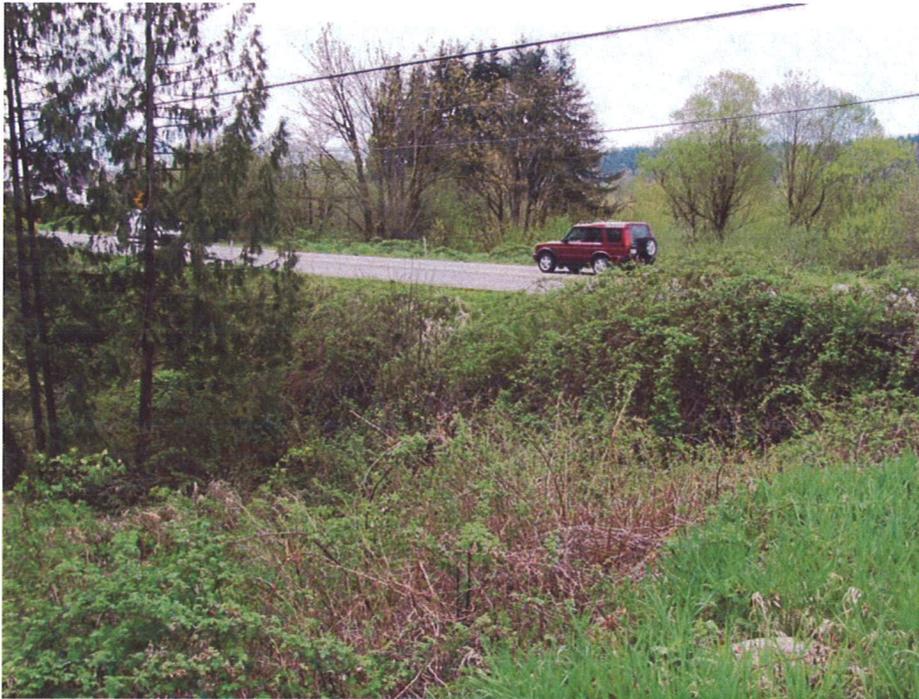
The site consists of a five-foot square concrete box culvert, 100 feet in length. The culvert is located on an embankment that is approximately 20 feet high (Figure 3). The culvert is sloped at 2.3 percent. The embankment spans the floodplain of Coe Clemmons Creek, just above the Snoqualmie River. Only a small portion of the culvert is visible, and the clearance for debris and water is extremely limited (See Figures 4 and 5). The clearance on the upstream side is only about five inches, while on the downstream side, the clearance is about 10 inches. The slope of the culvert is approximately 1.7 percent. During peak flows, there is likely pressure flow through the culvert; that is, there is additional head above the culvert inlet due to ponding. The pressure flow creates a greater amount of shear stress than open channel flow.

Figure 3. SR203 embankment over Coe Clemmons Creek culvert, looking downstream.

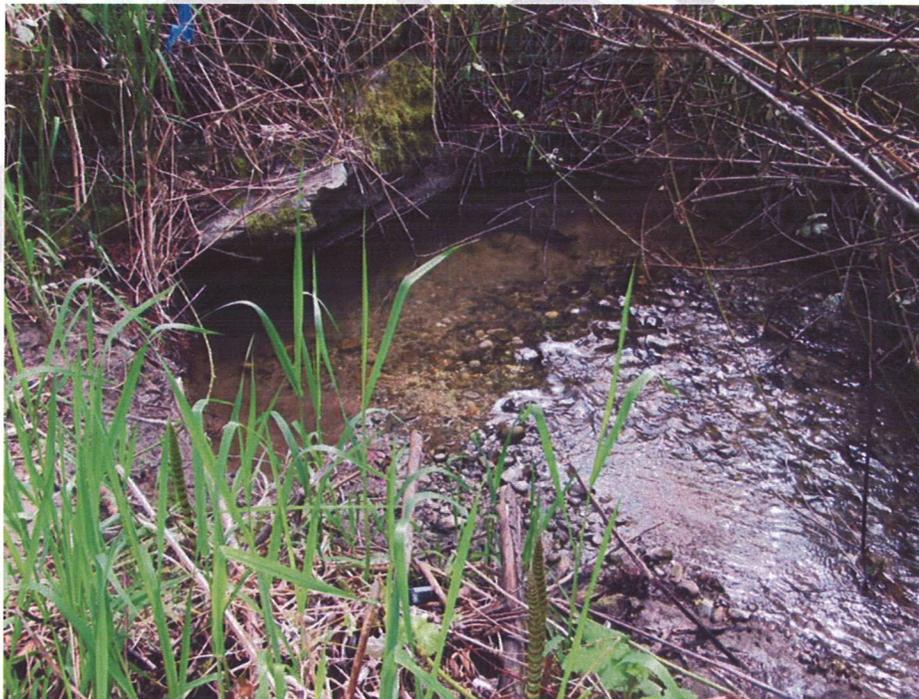
Figure 4. Coe Clemmons Creek at SR203 culvert outlet. Clearance is about 10 inches.

- Replace culvert with a 150-foot long clear-span bridge, allowing the creek to flow uninhibited across its alluvial fan.
- Continue clearing culvert of debris using a Vactor truck until the bridge can be built.

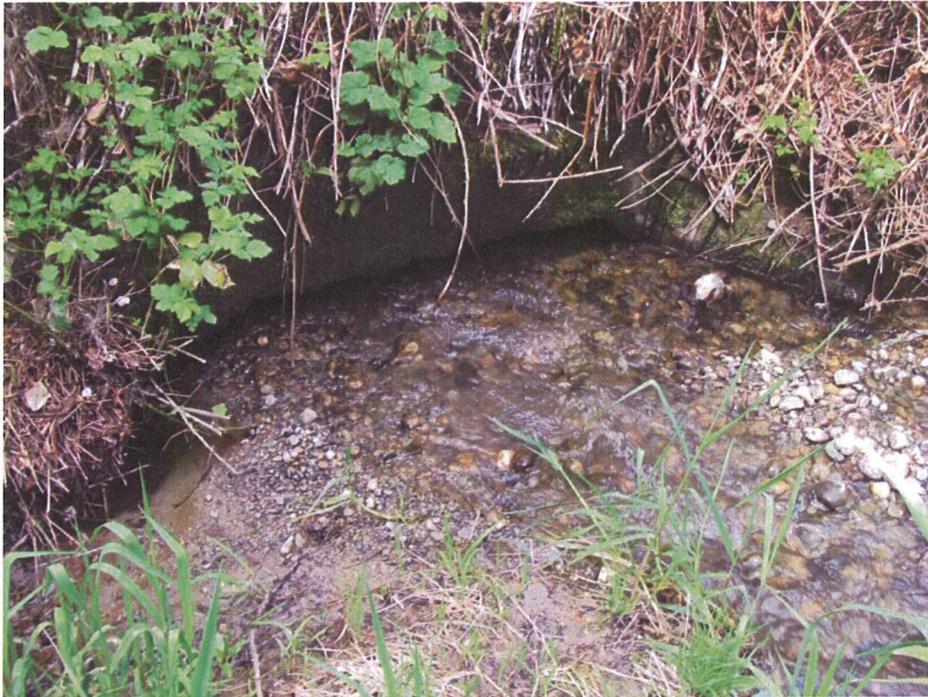
Figure 5. Coe Clemmons Creek at culvert inlet. Clearance is about 8 inches.

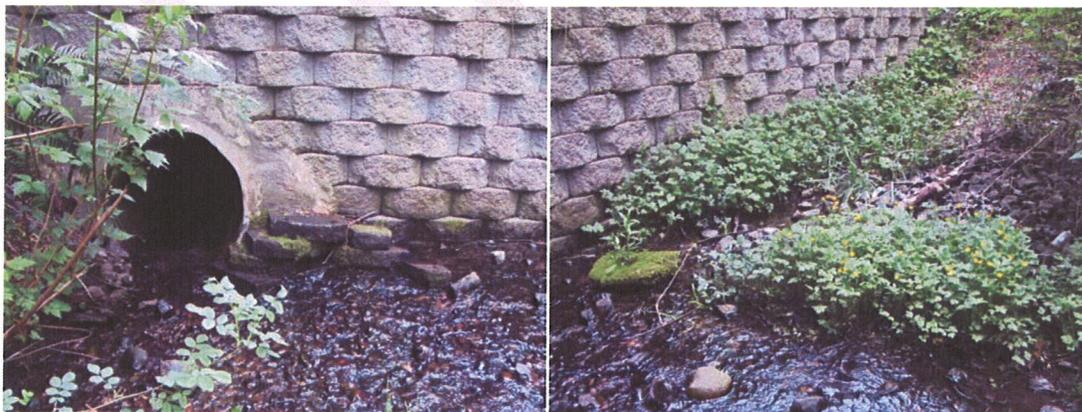
Figure 9. Culvert across Coe Clemmons Creek at 3rd Ave., downstream end of Reach 1.

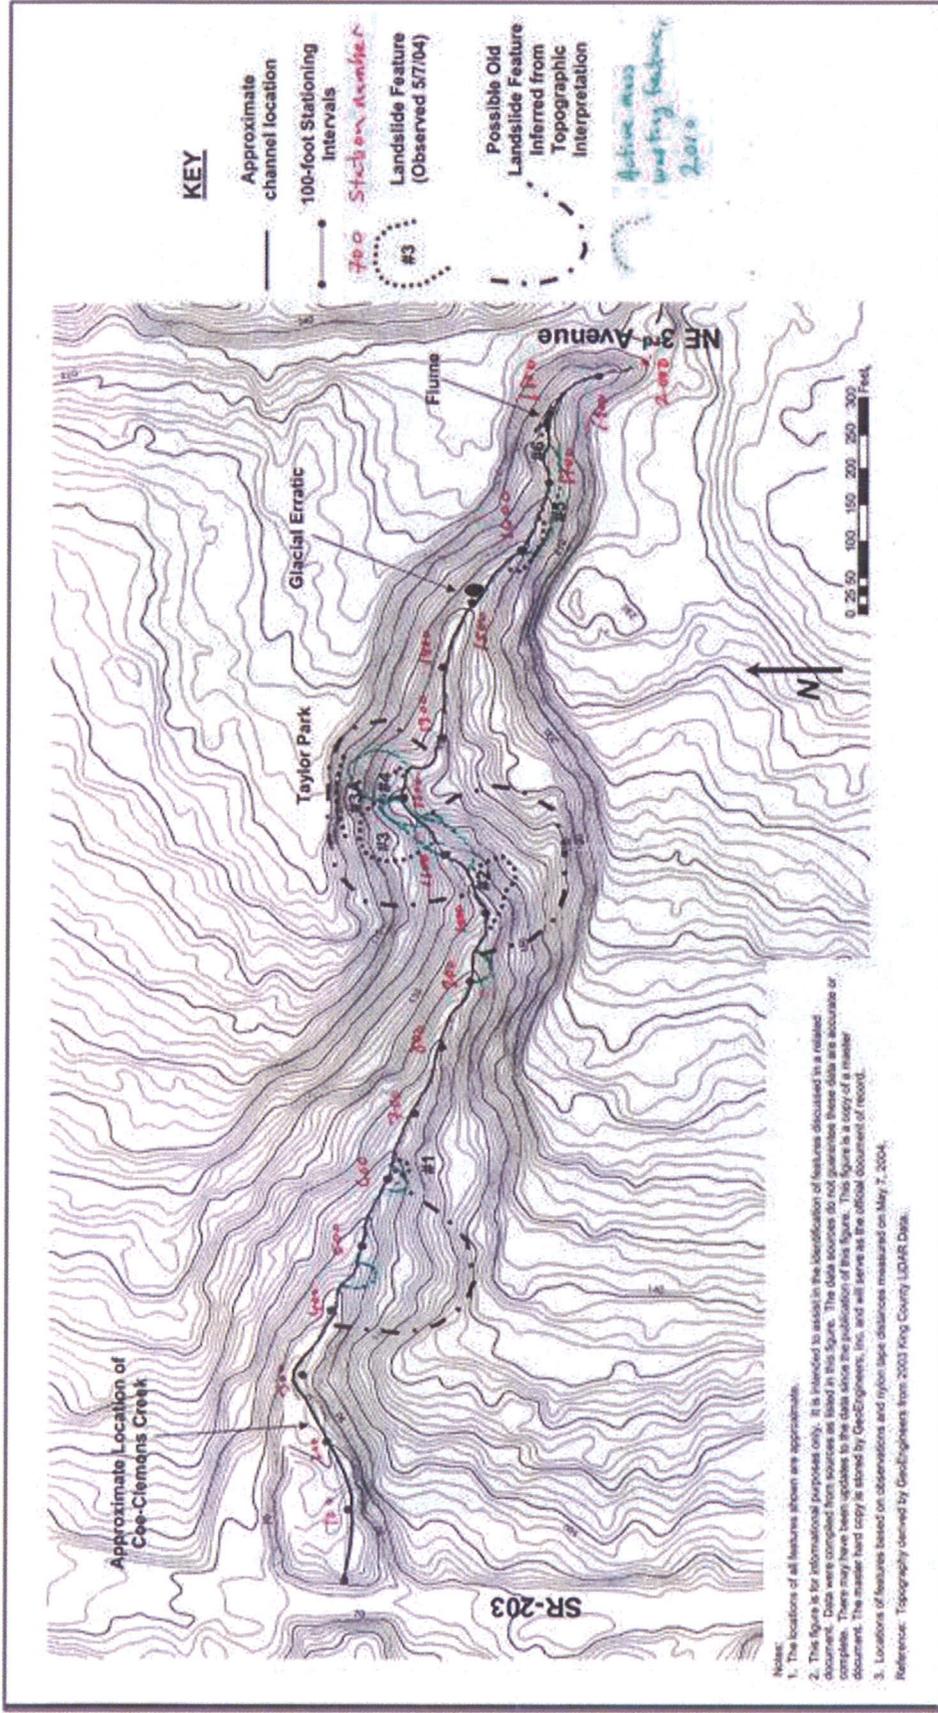
Figure 11 shows a map of the landslides within the gorge of Reach 2. There are numerous landslides, mostly coming from the left bank, but also there is a large landslide complex on the right bank. Active (or recently active) landslides were found at stations 4+50, 6+00, 8+75 (Figure 12), between at station 10+00 and Station 12+70, and between Station 16+00 and 17+90. There is a large landslide complex at station 1100. There is evidence of very recent and active landslides in this section (Figure 13). There is also a large log jam complex in the stream channel (Figure 14). There is a hazard of a large debris dam forming here because there are several landslides of various sizes immediately upstream. A debris jam could dam the stream, with the associated threat of a dam break flood. The Herrera (2006) survey did not note the presence of landslides in this area; however the GeoEngineers (2007) report, just a year later, described the landslide complex in some detail. An additional study was conducted in December of 2009 on the right bank landslides at station 11+50 (GeoEngineers, 2010).

Figure 11. Map of active and ancient landslides, Reach 2, Coe Clemmons Creek. Source: after GeoEngineers 2007.

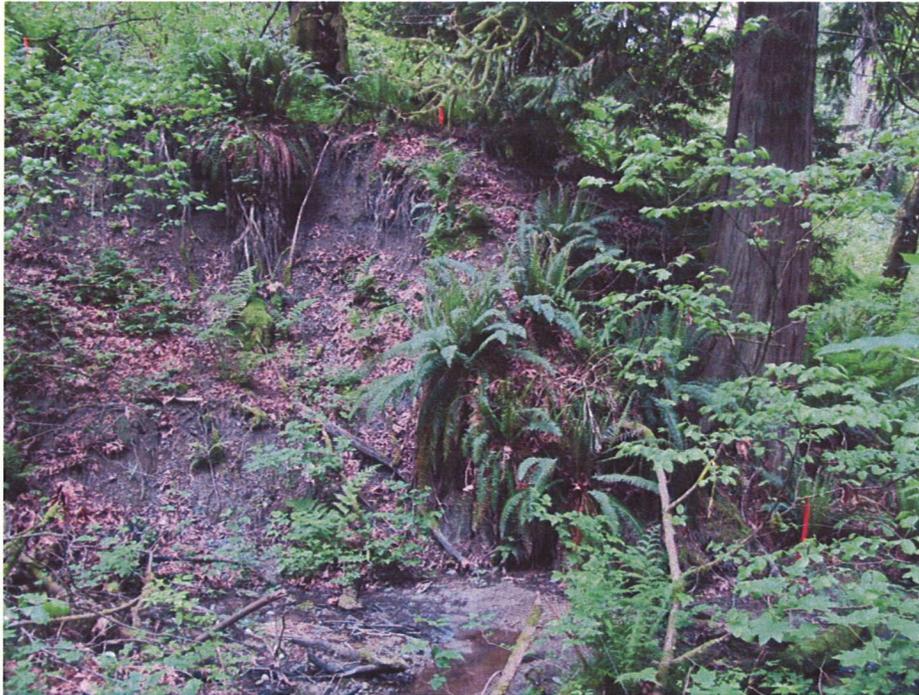
Figure 12. Earth flow/slide at Station 8+75, left bank at bottom left of photograph.

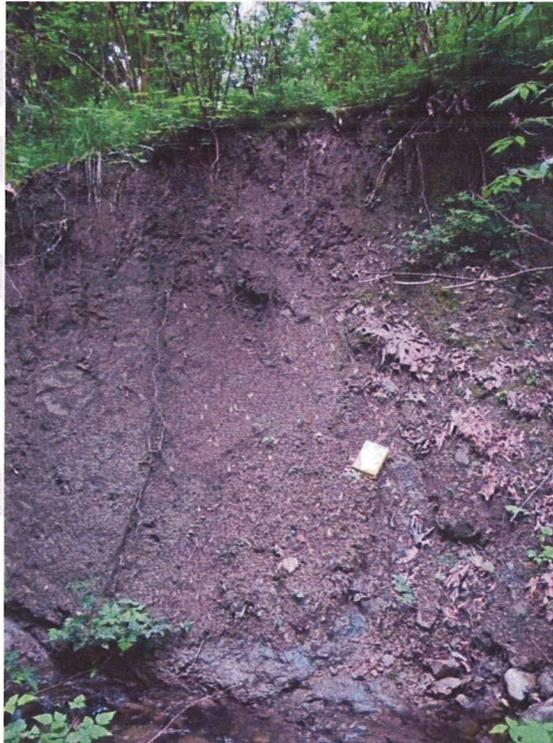
Figure 13. Streambank sloughing at Station 11+50. Ground at the base of the slope is saturated and easily mobilized.

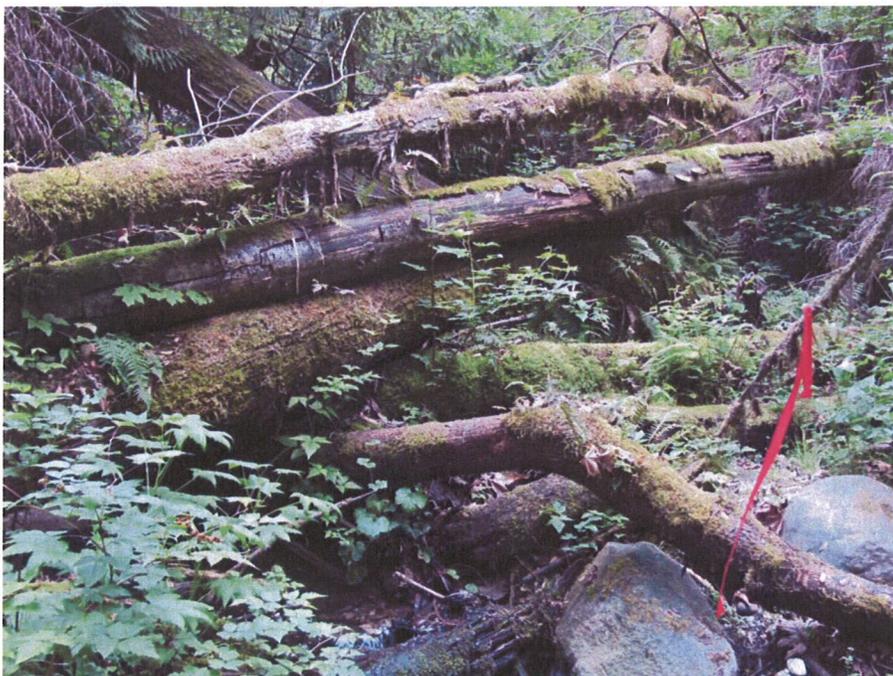
- There is potential for debris jam formation and dam break failure at station 11+75 and catastrophic affects downstream.

Figure 14. Debris jam at base of landslide complex at 11+75.

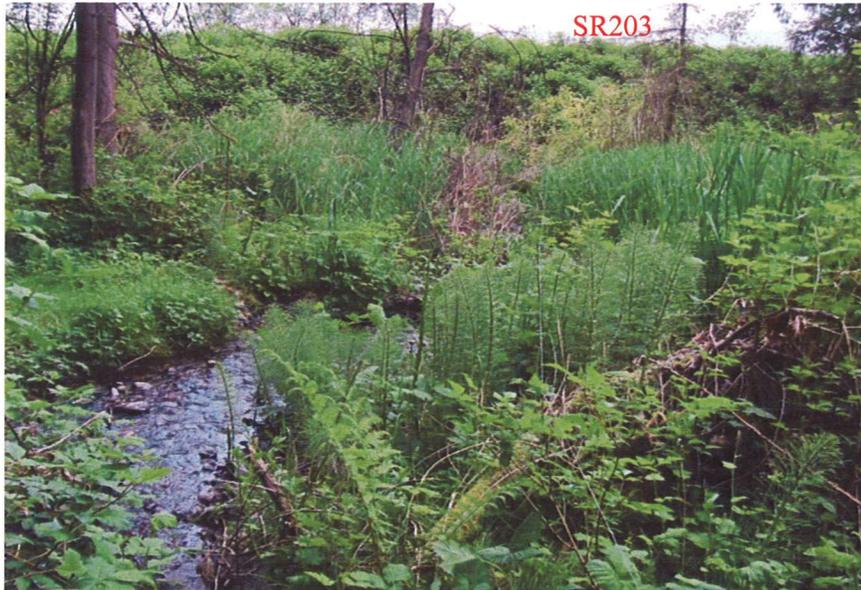
Figure 15. Reach 3 floodplain, looking downstream at SR203. Note dead and dying trees.

The floodplain in the vicinity of the highway (Reach 3) is dominated by non-native and/or invasive plants (blackberry, reed canary grass), and canopy cover is low (see Figure 15). Several trees have died and some are in the process of dying. These dead and dying trees are in the vicinity of the culvert, which suggests that they have been affected by sedimentation.

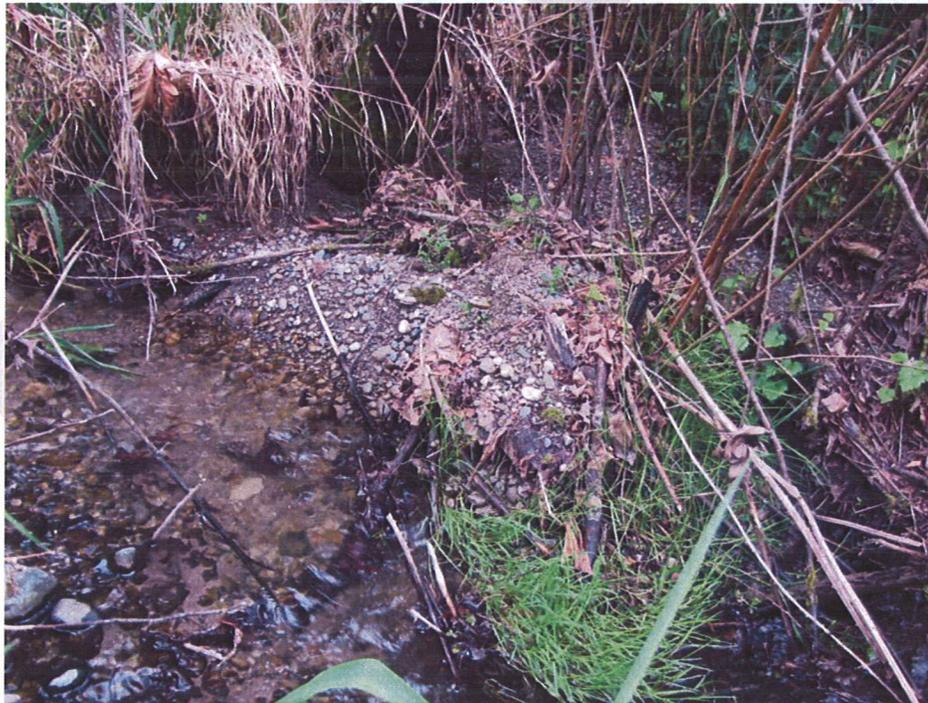
Figure 16. Recent aggradation in channel in Reach 3, 20 feet upstream from SR203 culvert inlet.

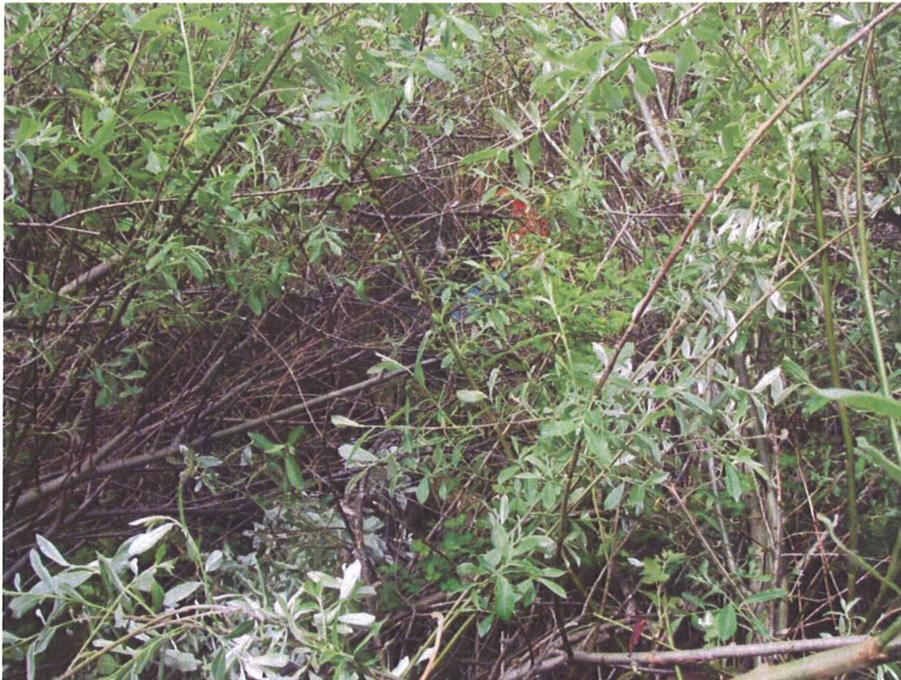
Figure 17. Reach 4, Coe Clemmons Creek. The person in the background is standing on branches 2-3 feet above the stream.
