Tree Retention Plan

for The Blueline Group
Project Location:
275th Ave NE and NE 150th Street
Duvall WA 98019

Friday, April 10, 2020

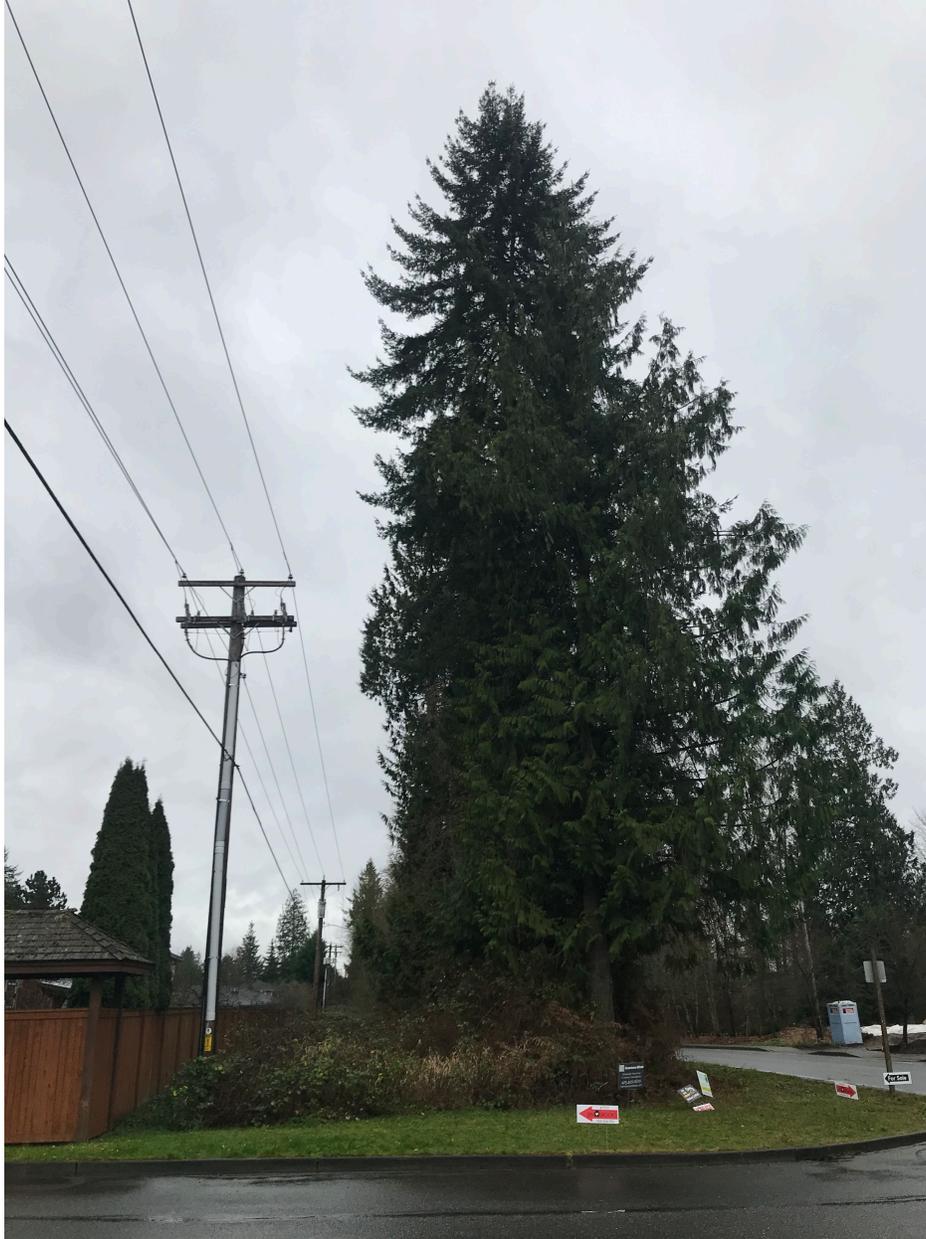
Image 2 - This photo looks south from NE 150th Street at the north end of the trail project. The evergreen trees here have a good outcome for preservation even though the new pathway will be within the critical root zone on the road side of the trees.

4. The pathway will be within the CRZ of the retained trees. Care will need to be taken when working around the trees by having an arborist on site during the initial excavation of the pathway to assess if any damage will result in their condition deteriorating. The contractor should be prepared to utilize alternative excavation methods such as hand digging, air or hydro excavation of soil, and perhaps lessening the depths of below grade material near the trees.

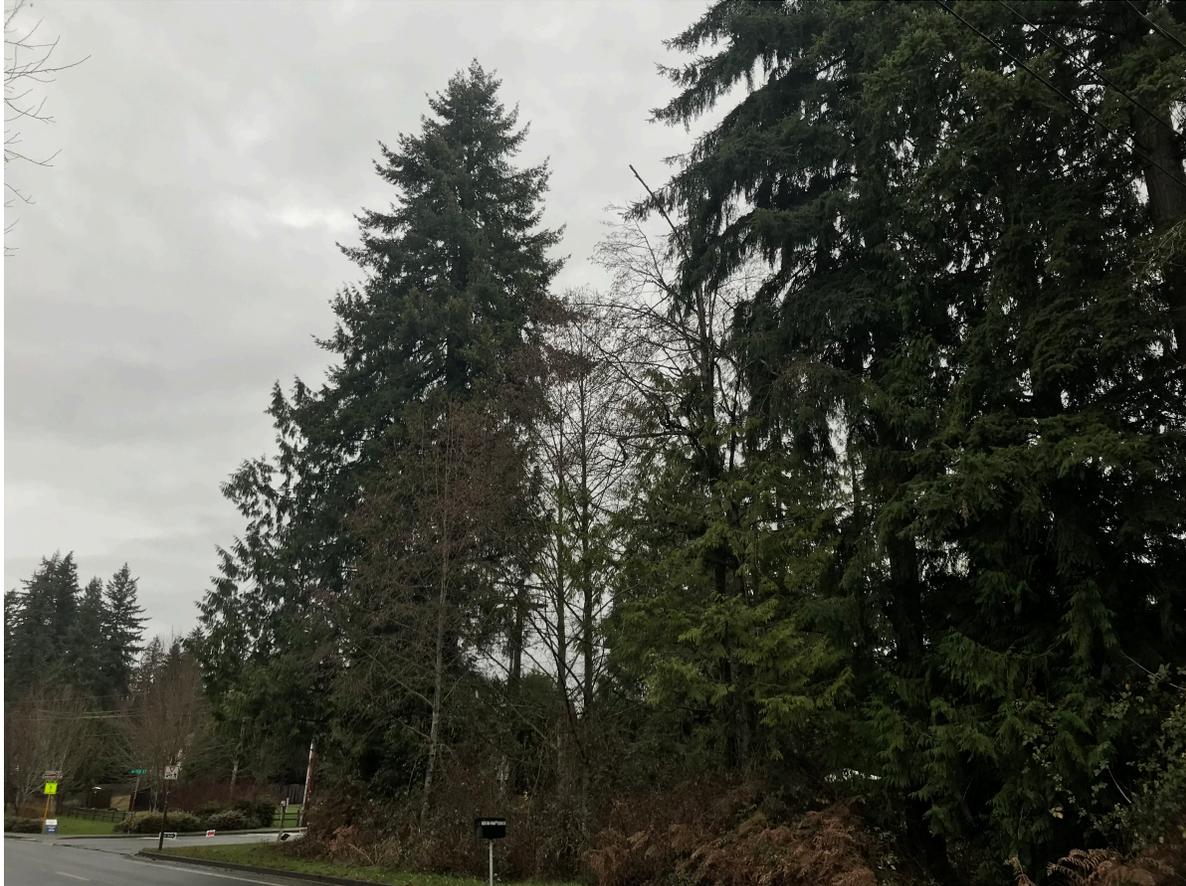
Image 3 - This is the same group of trees from Image 1 but looking to the NE. The evergreen trees in this image are all viable candidates for preservation.

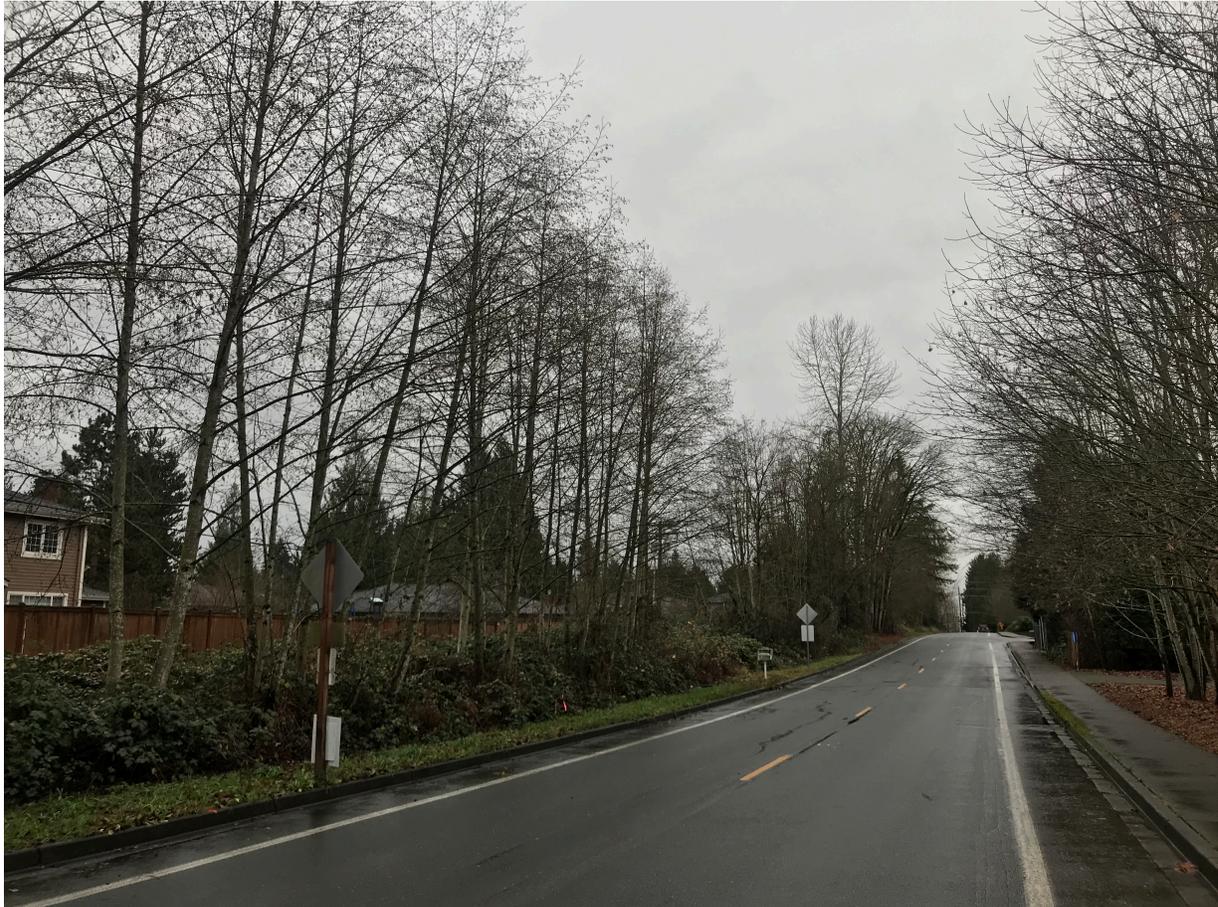
Image 4 - This photo looks south from the same vantage point as Image 2. Most of the trees on the left side of the photo are alder trees that are non-significant. They will be removed and replaced with paperbark maple trees.

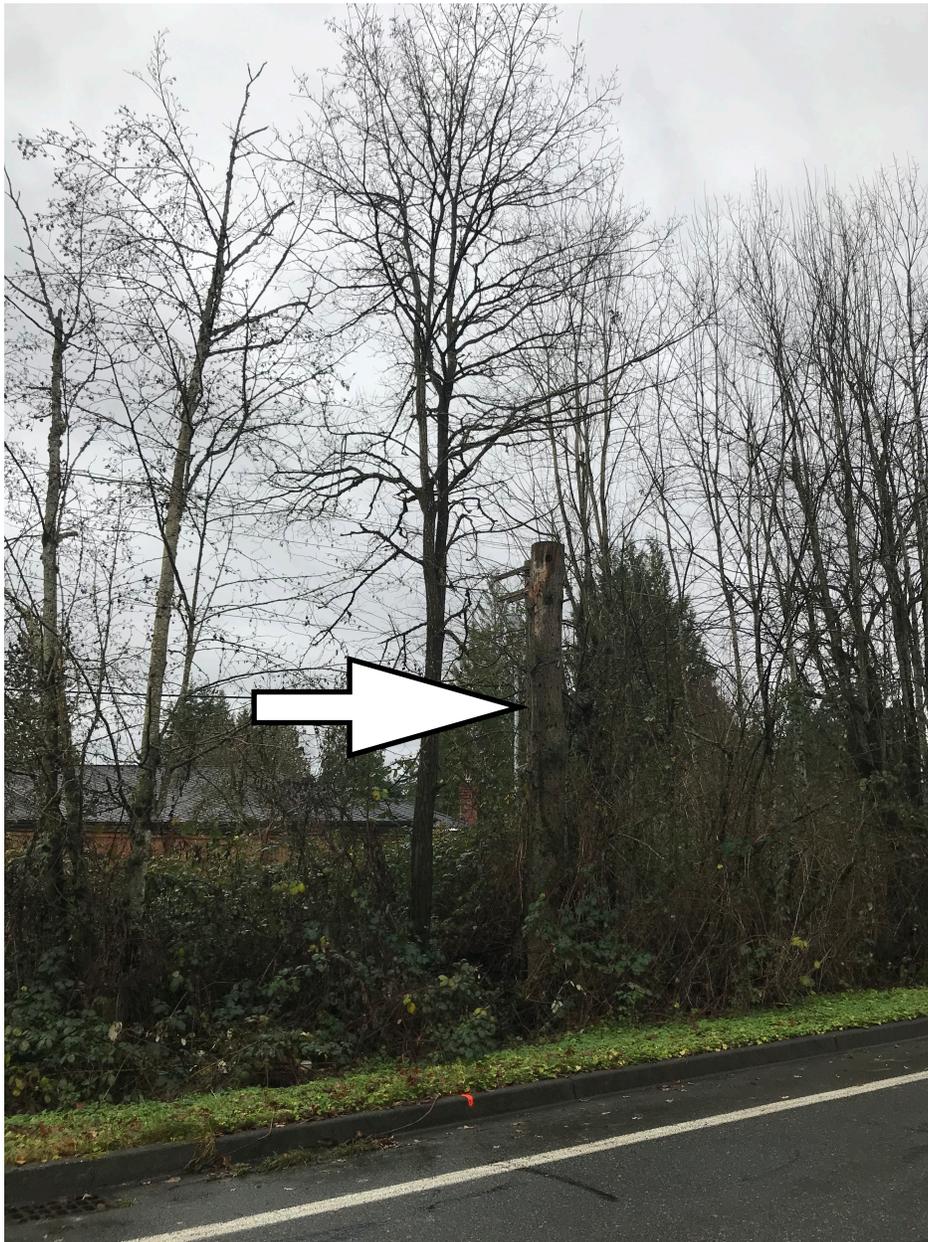
Image 5 - The white arrow points to the habitat snag that will likely remain as an ecological feature of the site. It is an approximately 20 foot tall dead Douglas-fir snag and is tagged as #5057.

Douglas-fir	5057	Yes*	26		26	13	Dead		Significant	Root	Possible		Significant	Good	Yes	Snagged
Western red cedar	5081	Yes	10		10	5			Minor							
Bigleaf maple	5082	Yes	50	Yes	50	25	Fair	Moderate	Significant	Root	Improbable	Medium	Severe	Good	Yes	13, 13, 18, 8, 14, 12, 18, 19, 16, 16, 17
Western red cedar	5084	Yes	40	Yes	40	20	Exceptional	Moderate	Significant	Root	Improbable	Low	Significant	Good	Yes	
Douglas-fir	5115	Yes	40	Yes	40	20	Exceptional	Moderate	Significant	Root	Improbable	Low	Significant	Good	Yes	
Western red cedar	5116	Yes	24		24	12	Good	Moderate	Significant	Root	Improbable	Low	Significant	Good	Yes

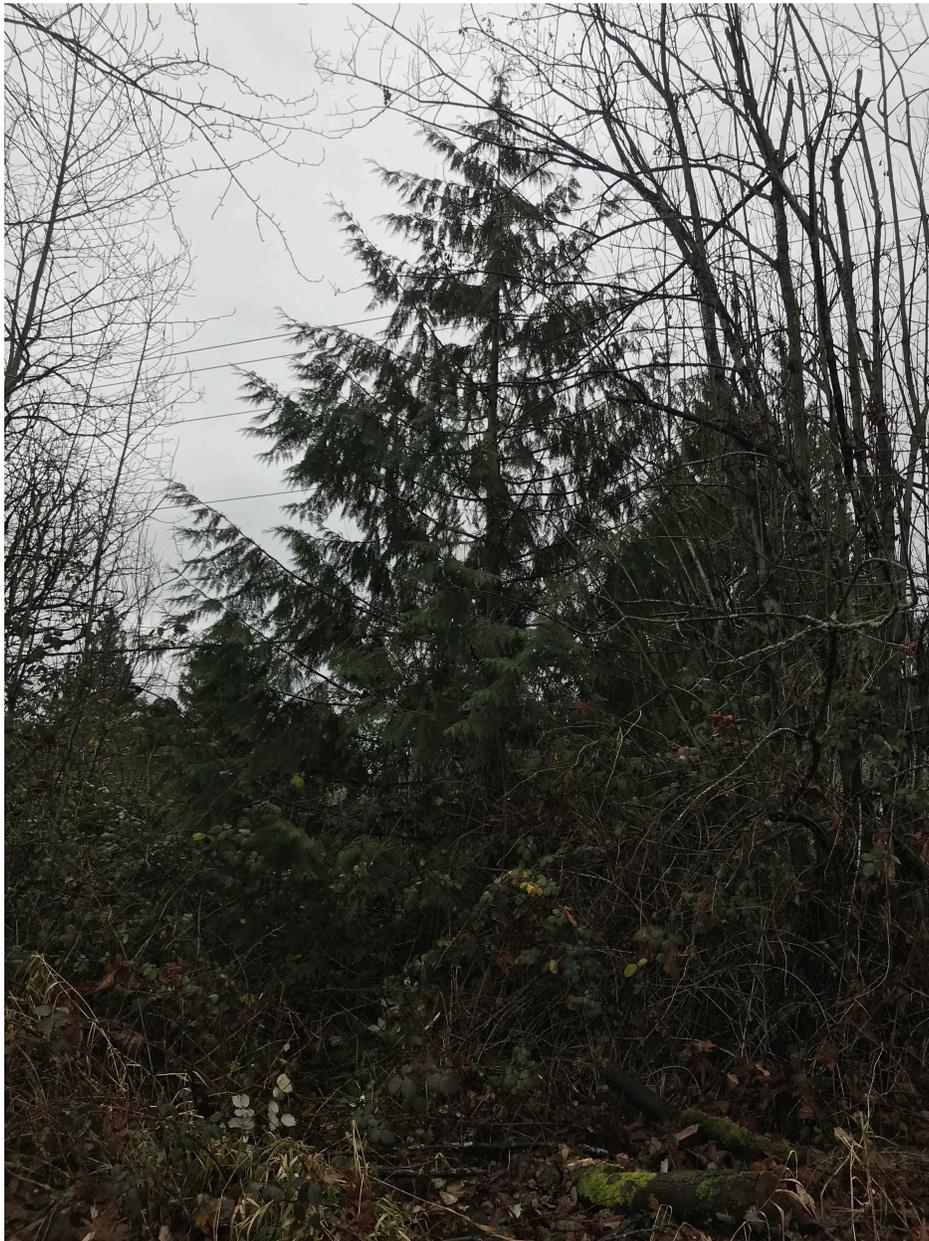
Image 6 - is a 10" DBH western red cedar, tag #5081, that will be retained.

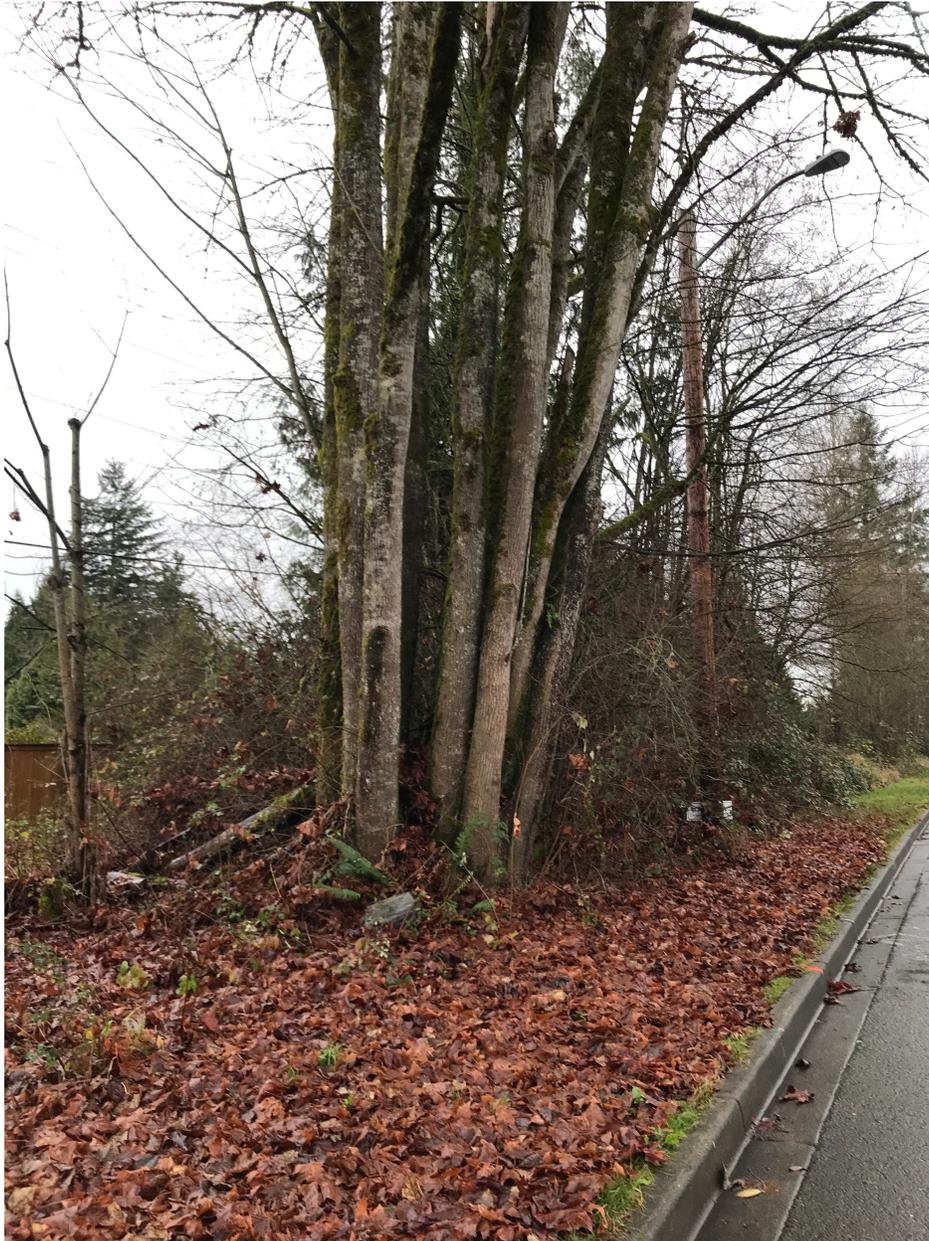
Image 7 - This multi-stemmed bigleaf maple, tag #5082, has a calculated DBH of 50". The path will pass on the back side of this tree between it and a large western red cedar (#5084).

- A. Because impact to the trees will only be on the west side of most of the trees, they should all remain viable and windfirm.
 - B. Specifically in regard to trees #5082 and #5084 - The path will pass between these two relatively large trees. An arborist should be on hand during the initial excavation or grading work to assess any roots encountered and evaluate whether the viability and windfirm status will be degraded due to the construction. At this time I believe they will continue to be viable and windfirm.

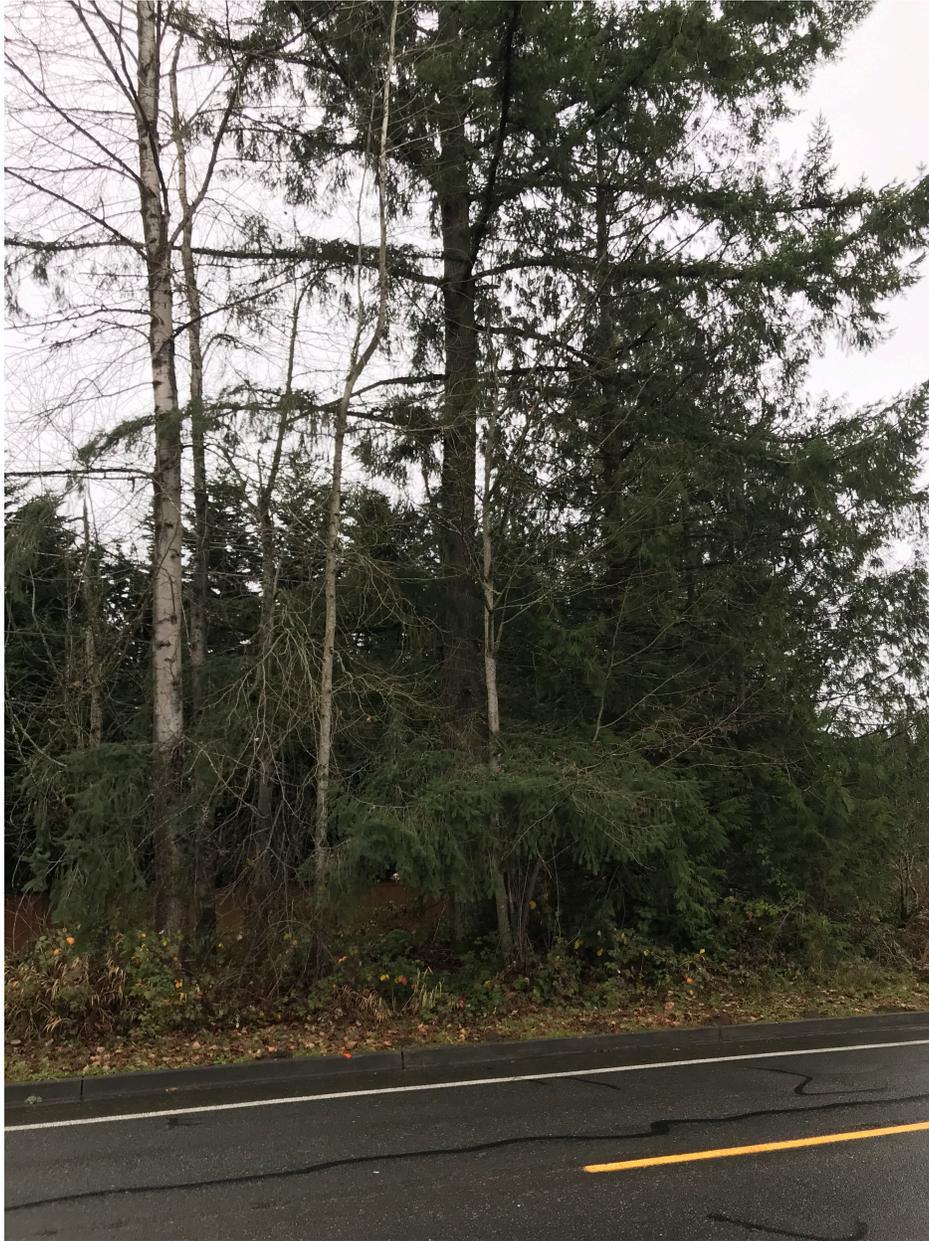
Image 8 - These two trees, Douglas-fir #5115 and Western red cedar #5116, are the last two trees to be preserved. From this point south to NE 145th Lane are mostly cottonwood and alder trees that will be removed and replaced with paperbark maple trees.

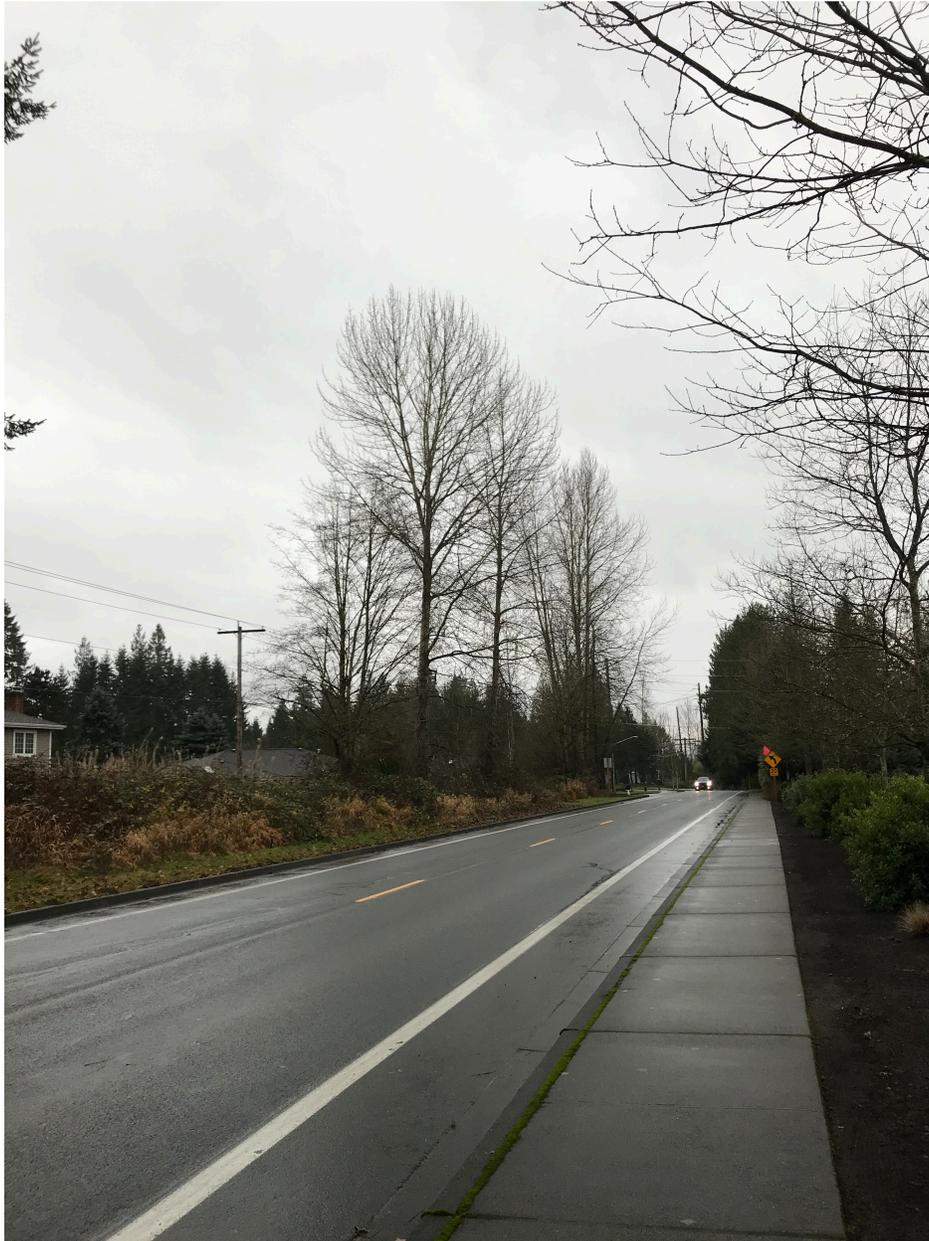
Image 9 - This view is to the south end of the pedestrian path. These non-significant trees will be removed and replaced.
