**Draft Site and Reach Assessment
Coe Clemmons Creeks
at SR203**

**Garrett Jackson, Hydrologist
WSDOT Environmental Services
Hydrology Program
June, 2010**

Site and Reach Assessment, Coe Clemmons Creek at SR203

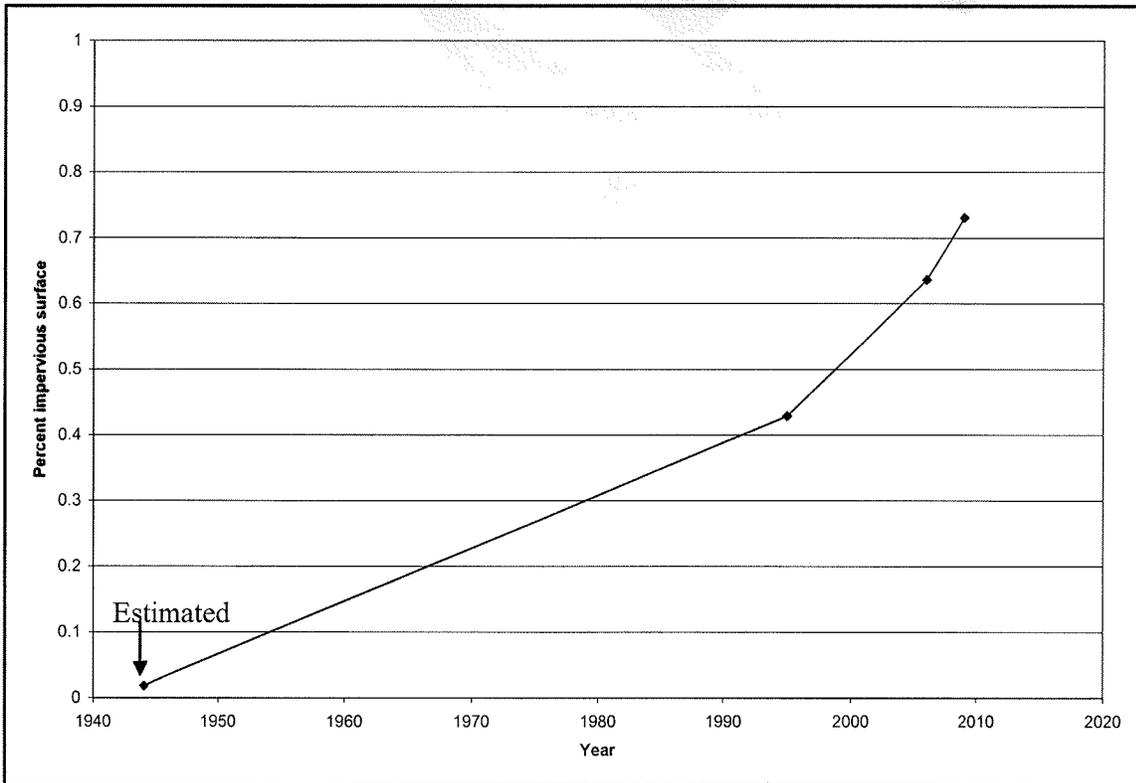
The watershed is within the city limits of Duvall, and is mostly developed into single family residences. In 2009, approximately 75 acres, or 27 percent, of the watershed was pervious; this was mostly the gorge reach of Coe Clemmons Creek, and Taylor Park. The rest of the watershed, 73 percent, is impervious, in the form of streets, houses, buildings, and yards. In 2006, the amount of pervious surface was 101 acres, or 37 percent. Therefore a decrease in pervious surface of 10 percent in three years occurred. Figure 6 shows the increase in impervious surface with time in the Coe Clemmons Creek watershed. Note that in this analysis, residential yards were considered impervious. This is because for the most part, the forest and forest soils are completely removed during subdivision construction. It is clear that there has been a dramatic increase in impervious surface within a very short amount of time. In fact, nearly all of the developable land outside the Coe Clemmons gorge has been developed.

Figure 6. Percent impervious surface area over time, Coe Clemmons Creek watershed.

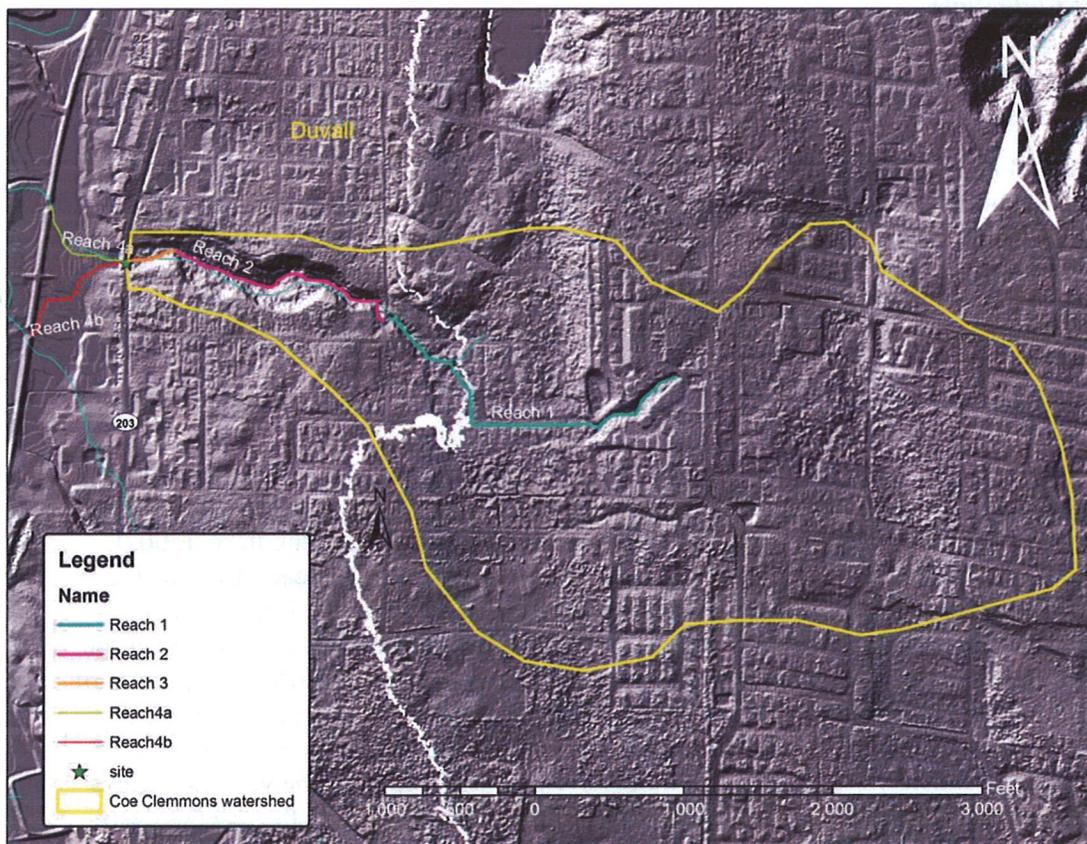
The small watershed of Coe Clemmons Creek drains the east slope of the lower Snoqualmie River Valley. It ranges in elevation from about 50 feet to 450 feet above sea level. It has a west-southwest aspect. The stream was divided into three reaches by GeoEngineers (2007), spanning the area between the drainage divide and the culvert at SR203. Reach 1 drains the gentle to moderately sloping plateau above the Snoqualmie River. Reach 2 is the steep, confined gorge sections. Reach 3 was the relatively short section between the mouth of the gorge and the SR203 culvert inlet. A fourth reach is considered in this report, which is the portion of the stream downstream from the culvert to Snoqualmie Trail. Reach 4 is primarily in the alluvial fan section, where the creek enters the very flat Snoqualmie River floodplain. Figure 7 shows the reaches and also the 2003 LiDAR imagery. The topography of the various reaches can be clearly seen. Figure 8 shows a longitudinal profile of the creek with the reaches designated. The stationing used by the City of Duvall is adopted here. Station "0+00" is at the SR203 culvert inlet. Stationing upstream from this point is positive and downstream from the culvert is negative.

Figure 7. Reach delineation on Coe Clemmons Creek, showing LiDAR topography

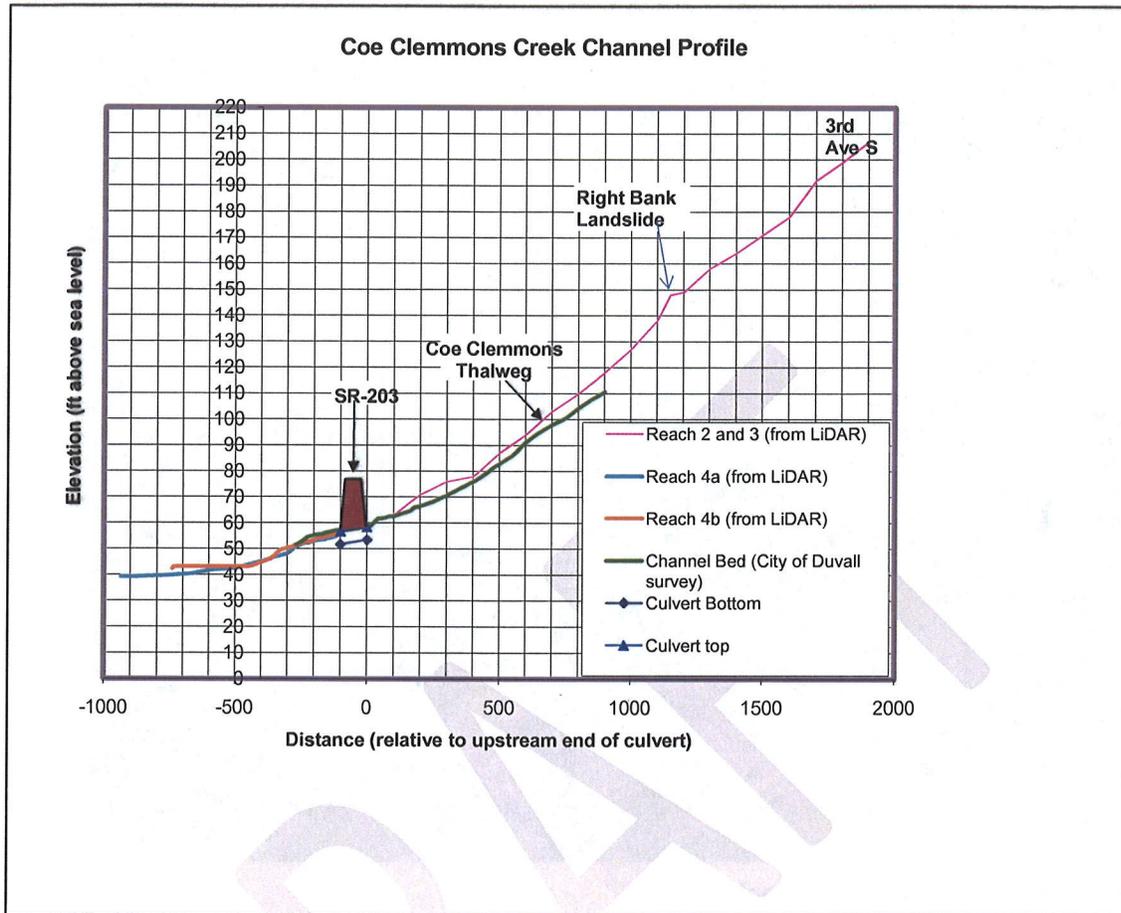
Figure 8. Longitudinal profile of Coe Clemmons Creek, showing reaches 2, 3, and reach 4a and 4b.

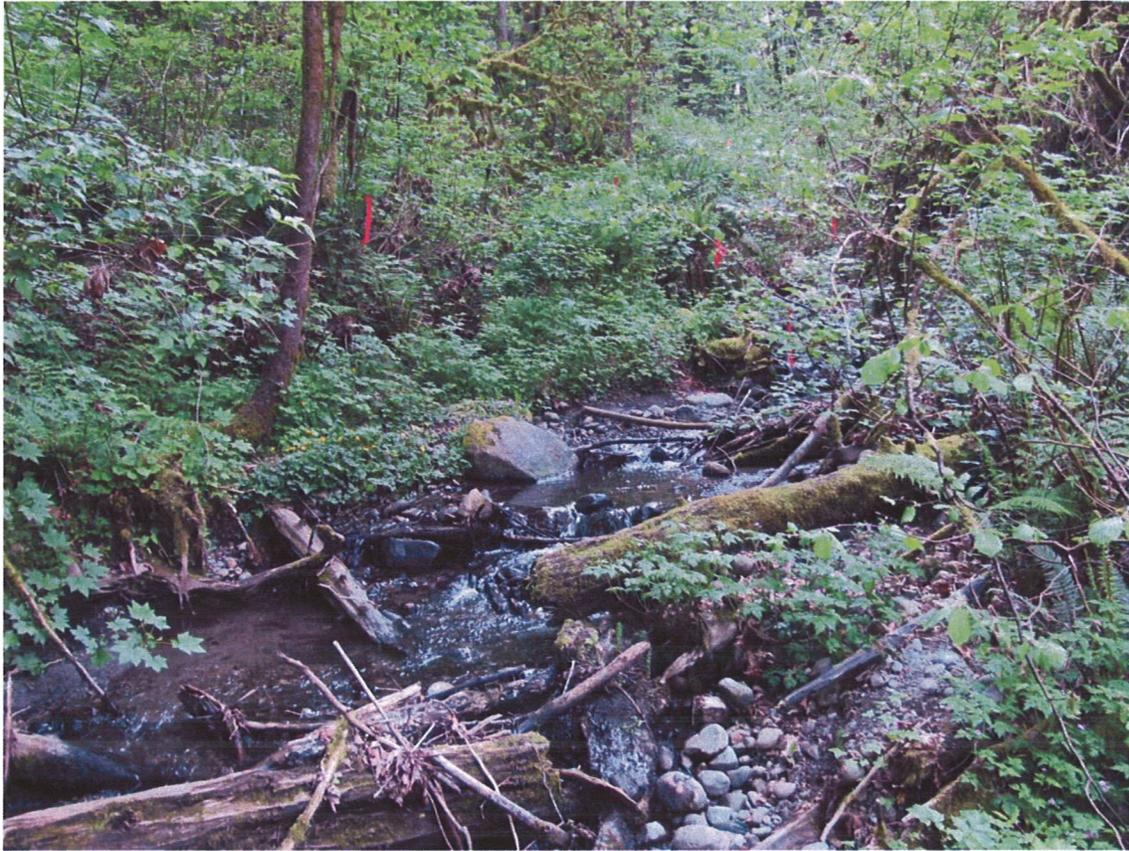
Reach 2 is in a steep gorge carved into the glacial deposits. The gradient varies from between four and 20 percent. The stream channel is dominated by gravel, with a significant amount of cobbles as well as sand. There are some portions of the stream where boulders form the substrate. We speculate that these are lag boulders from eroded glacial sediment. Between Stations 10+40 to 11+10, these lag boulders form a knickpoint in the stream profile with a gradient of 25 percent. The bankfull width varies from 30 feet near the downstream end of the reach to about 10 feet in the upper portion of the reach. The average bankfull width is approximately 14 feet. Average bankfull depth is about five feet. Figure 10 shows a picture of a typical section of this reach.

Figure 10. Typical cross-section, Reach 2.

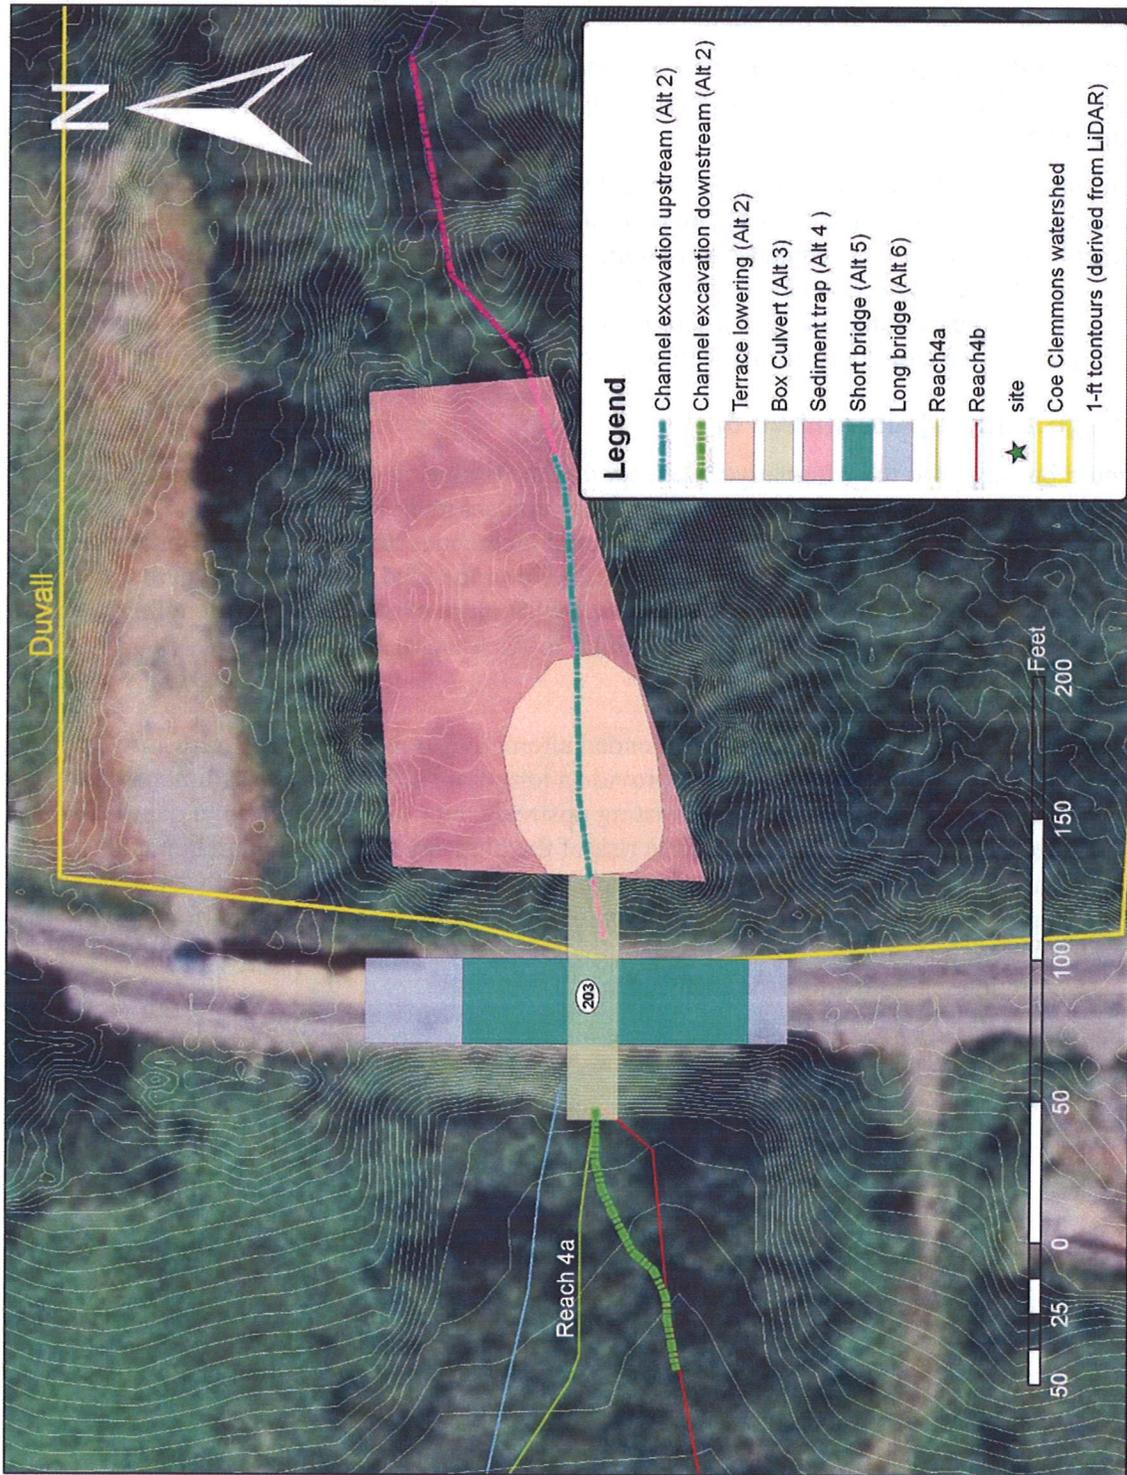
Table 3 summarizes the alternatives and their advantages and disadvantages. We considered six main alternatives, including no action (continued periodic dredging as needed). Figure 18 shows the elements of all alternatives at the stream crossing.

This alternative has the advantage, compared to the previous alternative, of providing significantly more sediment storage. The stream channel would be excavated 150 feet upstream from the culvert inlet, as shown in Figure 18. Excavation would take place downstream from the culvert outlet, also. The excavation would extend down to the culvert invert (about 4.5 feet) and taper to match the existing grade. The excavated channel would be about 10 feet wide with 2:1 sideslopes. In addition, the floodplain terrace that has built up around the culvert inlet would be lowered by about 2 feet. All disturbed areas other than the channel bottom would be re-vegetated. The channel would be excavated 100 feet downstream; the low spot where Reach 4 b is located (see Figure 18) could be used to increase the slope of the channel. This would require excavating the channel in the direction of the low spot and tapering to match the existing grades. Doing this could negatively affect the Copper Hill mitigation site, and new mitigation would likely be necessary.

Figure 18. Schematic of the elements of alternatives considered.

Alternative 6 (150-foot bridge) is the recommended alternative, due to its ability to restore most of the sediment transport capacity and provide a long-term solution to the sedimentation issue. Given likelihood of continued mass wasting upstream, and the possibility of a dam-break flood, a bridge would essentially eliminate the risk of the highway and sewer main being affected. Alternatives 3, 5, and 6 provide the best opportunities to improve sediment transport capacity and protect the highway. In consideration of the amount of construction effort involved, Alternative 6 is only somewhat more complex than alternative 3 or 5, and provides a benefit of removing a gentle dip in the highway.
